**CASE REPORT**

**ENGINEERING SCIENCES**

## Application of 3D Laser Scanner to Forensic Engineering

### Case 1 with Discussion

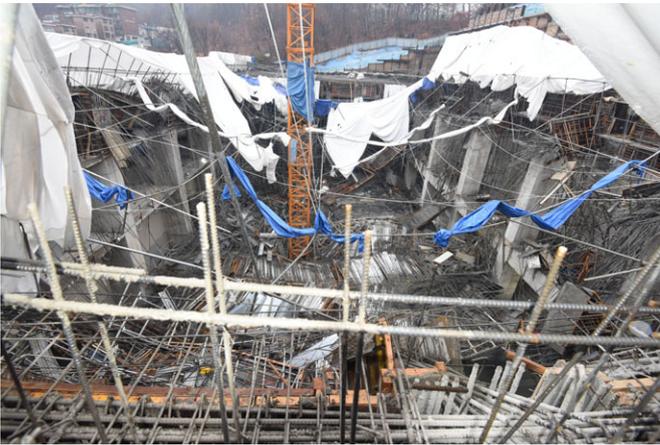
FIG. 2—The collapsed area of the gymnasium.

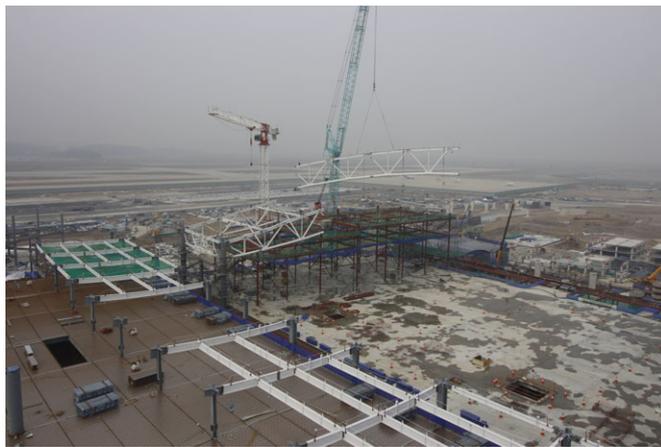
FIG. 7—The crane just before the collapse recorded by CCTV.

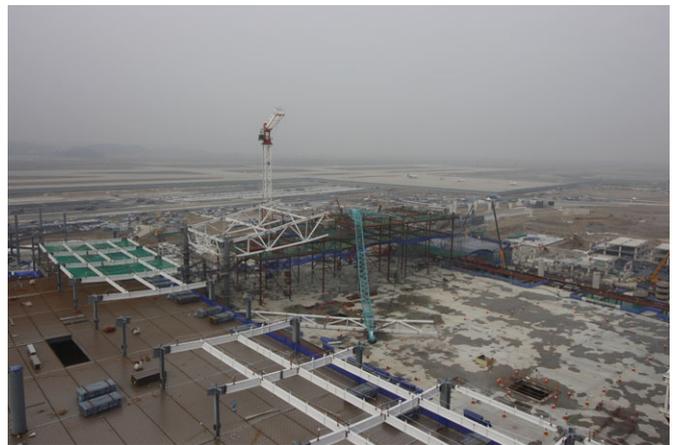
FIG. 8—The crane just after the collapse recorded by CCTV.

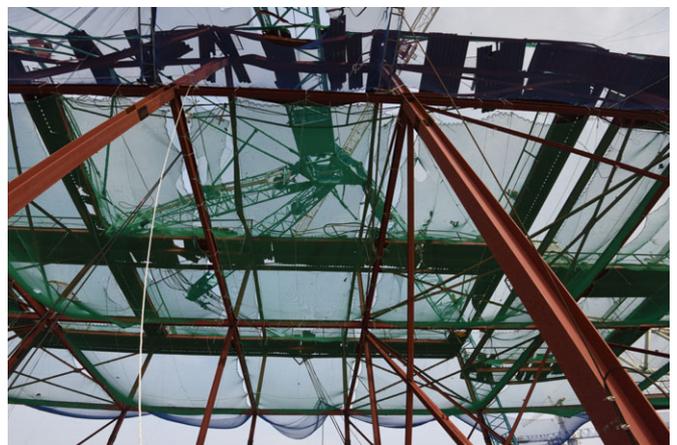
FIG. 9—The collapsed boom, the ruffing jib, and the front and rear struts located on the roof being constructed. The jib angle with the struts remained undamaged.
